## Incident Investigation Report Summary

IIR Number  
2104EPA0000532-I001

### District Office Investigation Report

Ohio Environmental Protection Agency Emergency Response Unit  
 District Office Investigation Report - Photograph Log  
 Incident Number: 2104EPA0000532

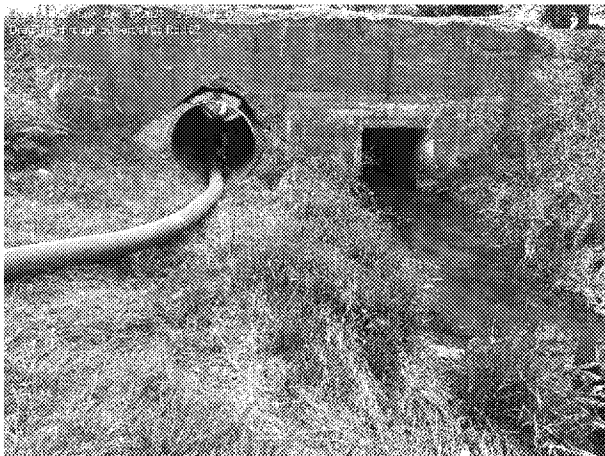
Name:	21-0532 (01)	Name:	21-0532 (02)

1255: The OSC arrived at the road culvert at County Road 159. The OSC took a photograph of the application line present in the road culvert.

Taken By:	OSC IRWIN	Taken By:	OSC IRWIN
Date:	4/18/2021	Date:	4/17/2021
Description	Drag line through culvert	Description	Scene of break in line
Name:	21-0532 (03)	Name:	21-0532 (04)

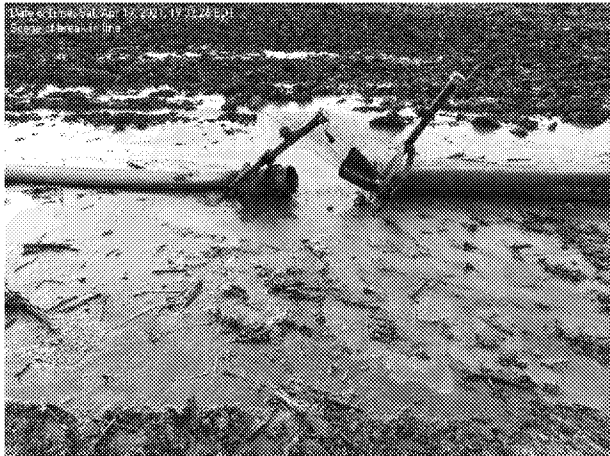
1936: The OSC arrived at the scene of where the initial release occurred. The OSC observed the area in the field where the line developed the leak. A black semi solid sludge- like material was observed on the field. The OSC inspected the drainage ditch where the material entered.

While conducting land application activities of liquid waste to an agricultural field, a hole developed in the line, releasing an estimated 2,500 gallons of material. An unknown amount of liquid waste entered an unnamed tributary of Whetstone Creek. This is in violation of Ohio Revised Code 6111. and Ohio Administrative Code 3745-1-04.

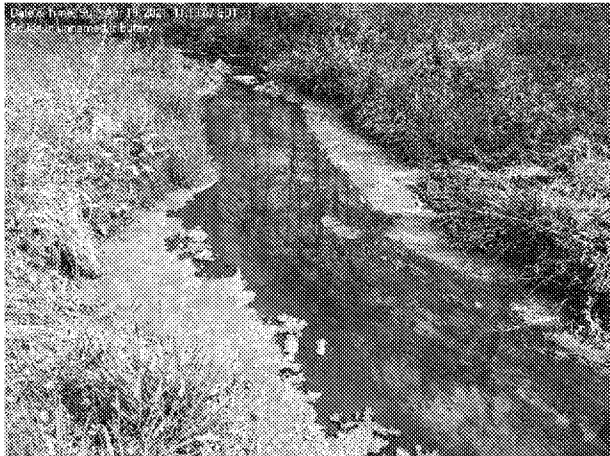
Taken by:	OSC IRWIN	Taken by:	OSC IRWIN
Date:	4/17/2021	Date:	4/18/2021
Description	Material entrance into surface water	Description	Solids in unnamed tributary

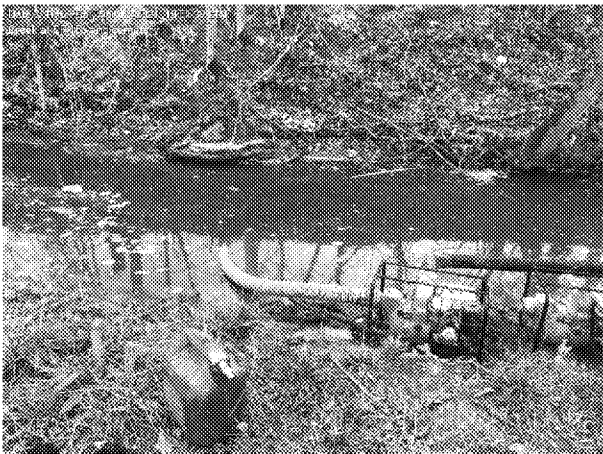
Name:	21-0532 (05)	Name:	21-0532 (06)

Taken By:	OSC IRWIN	Taken By:	OSC IRWIN
Date:	4/17/2021	Date:	4/18/2021
Description	Creek at CR 156 and cemetery	Description	Earthen dam
Name:	21-0532 (07)	Name:	21-0532 (08)

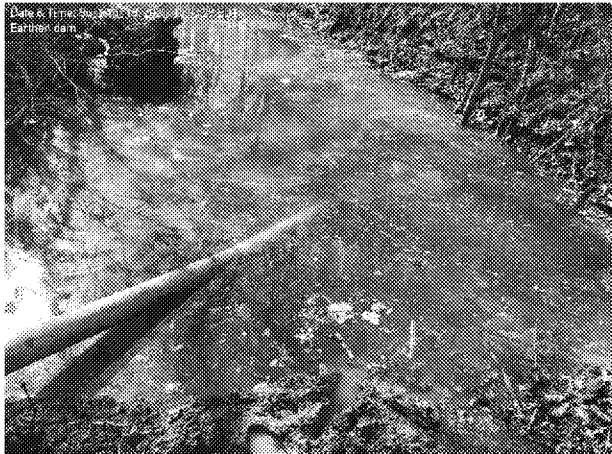
1756: The OSC arrived on scene. The OSC met with Officer Motsinger at the Renergy property near Co Rd 156 and Co Rd 159. Officer Motsinger left the scene to travel downstream to inspect Whetstone Creek. The OSC met with Oberfield and Ashton. Containment options were discussed. An earthen dam would be installed in the tributary upstream of Co Rd 156. Once the dam was installed, a pump would be used to transfer accumulated liquids and released material from behind the dam into a vacuum trailer for transport

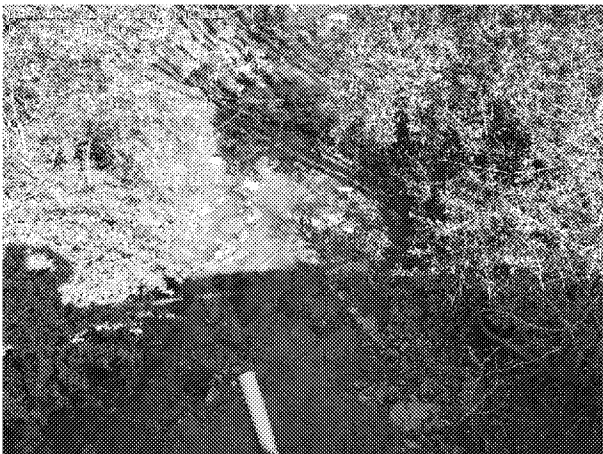
1015: The OSC met with Staley, Ashton and Ropke regarding the installation of an earthen dam on the Staley Farm property. Ashton and Staley discussed the installation of an earthen dam on the Staley property. Once the material contained by the upper dam (Co Rd 156 dam) had been removed and the tributary remediated, Raw Handling and Renergy would begin addressing the tributary on the Staley property. Fresh water would be used to flush the tributary to the lower dam installed on the Staley property. Raw Handling would pump the flush water from the dam to the Renergy facility.

Taken by:	OSC IRWIN	Taken by:	OSC IRWIN
Date:	4/18/2021	Date:	4/17/2021
Description	Downstream dam Staley property	Description	Whetstone Creek at Co Rd 21 bridge

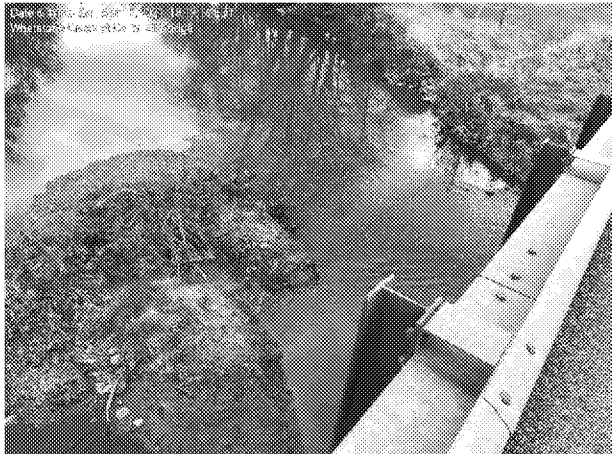
1817: The OSC arrived at the County Road 21 bridge over Whetstone Creek. The creek appeared dark brown in color. The OSC could not observe the bed of the creek. The OSC screened the creek for dissolved oxygen (YSI meter) and ammonia (test strips). The D. O. was 8.43 mg/L. The ammonia was 3.0 ppm.

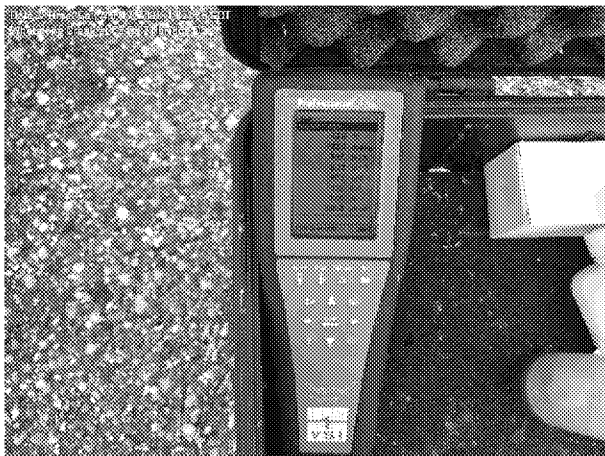
Name:	21-0532 (09)	Name:	21-0532 (10)

Taken By:	OSC IRWIN	Taken By:	OSC IRWIN
Date:	4/17/2021	Date:	4/17/2021
Description	Whetstone Creek at Co Rd 21 bridge DO	Description	Whetstone Creek at Co Rd 21 bridge Ammonia
Name:	21-0532 (11)	Name:	21-0532 (12)

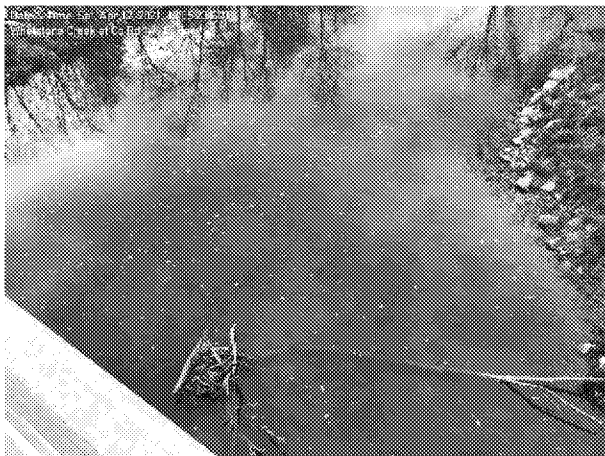
1845: The OSC arrived at the County Road 146 bridge over Whetstone Creek to screen the waterway (D.O. = 8.50 mg/L, ammonia = 0.5 ppm). The creek was normal in appearance. The OSC could observe the rocky bed of the waterway.

Taken by:	OSC IRWIN	Taken by:	OSC IRWIN
Date:	4/17/2021	Date:	4/17/2021
Description	Whetstone Creek at Co Rd 146 bridge	Description	Whetstone Creek at Co Rd 146 bridge DO

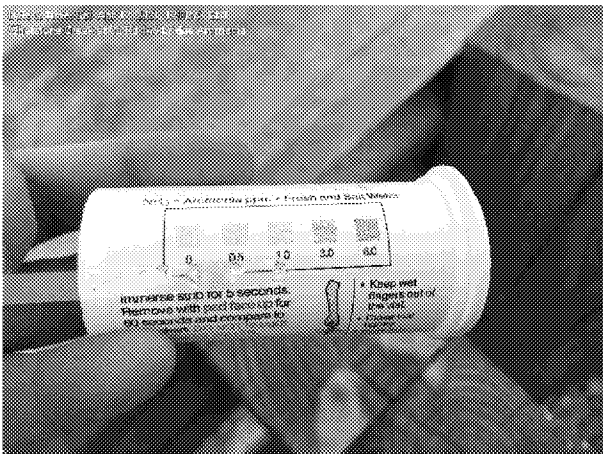
Name:	21-0532 (13)	Name:	21-0532 (14)

Taken By:	OSC IRWIN	Taken By:	OSC IRWIN
Date:	4/17/2021	Date:	4/18/2021
Description	Whetstone Creek at Co Rd 146 bridge Ammonia	Description	Aeration at CR 21
Name:	21-0532 (15)	Name:	21-0532 (16)

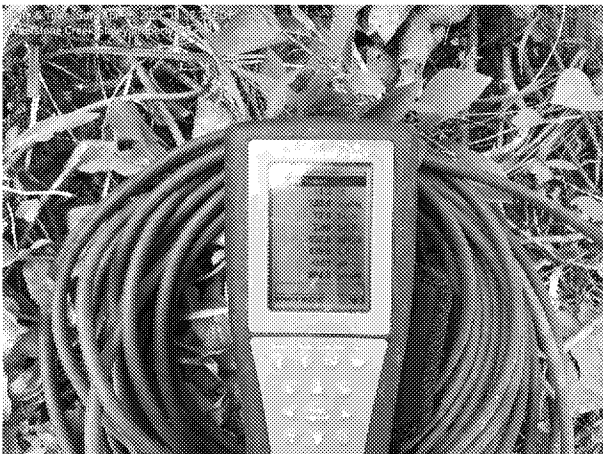
1123: The OSC arrived on the Staley property to screen Whetstone Creek (D.O. = 7.90 mg/L). the lower dam was installed on the Staley property.

Taken by:	OSC IRWIN	Taken by:	OSC IRWIN
Date:	4/18/2021	Date:	4/18/2021
Description	Whetstone Creek Staley property DO	Description	Whetstone Creek at Co Rd 21

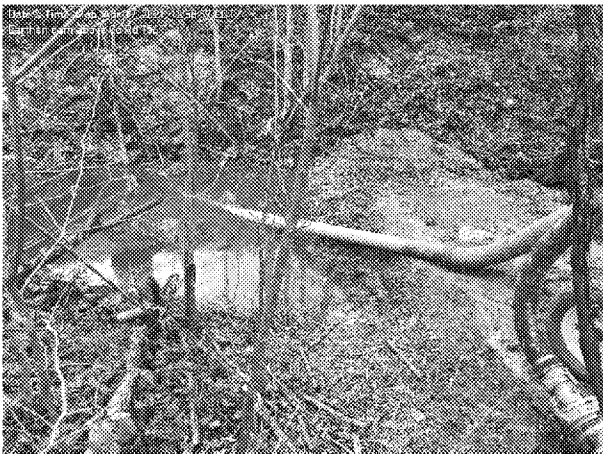
Name:	21-0532 (21)	Name:	21-0532 (22)

Taken By:	OSC IRWIN	Taken By:	OSC IRWIN
Date:	4/19/2021	Date:	4/19/2021
Description	Earthen dam above Co Rd 156	Description	Unnamed tributary below Co Rd 156
Name:	21-0532 (23)	Name:	21-0532 (24)

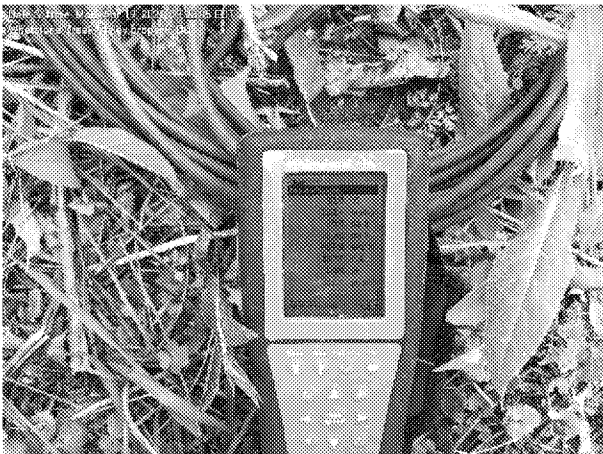
1314: The OSC and Sheerin arrived at the Staley property. The OSC screened Whetstone Creek (D.O. = 7.46 mg/L).

Taken by:	OSC IRWIN	Taken by:	OSC IRWIN
Date:	4/19/2021	Date:	4/19/2021
Description	Whetstone Creek Staley property DO	Description	Whetstone Creek Co Rd 21

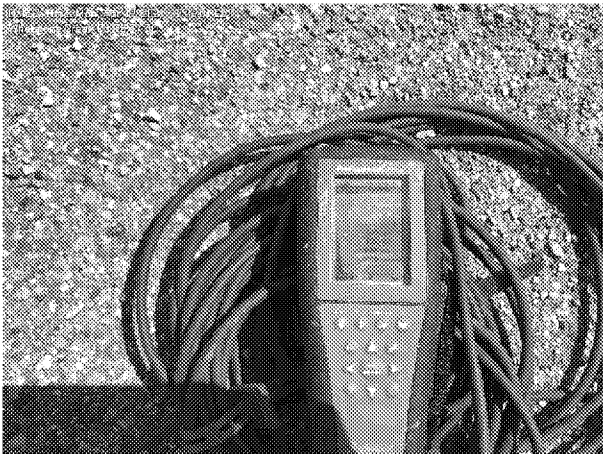
Name:	21-0532 (25)	Name:	21-0532 (26)

1329: The OSC and Sheerin arrived at County Road 21. The OSC screened Whetstone Creek (D.O. = 8.52 mg/L, ammonia = 0.0 ppm).

Taken By:	OSC IRWIN	Taken By:	OSC IRWIN
Date:	4/19/2021	Date:	4/19/2021
Description	Whetstone Creek Co Rd 21 DO	Description	Whetstone Creek Co Rd 21 Ammonia
Name:		Name:	
Taken by:	Choose an item.	Taken by:	Choose an item.
Date:	Click or tap to enter a date.	Date:	Click or tap to enter a date.
Description		Description
